Final Waikele Stream Bioassessment

Katina Dove Henderson
Environmental Planning Office
Hawaii State Department of Health
December 2003

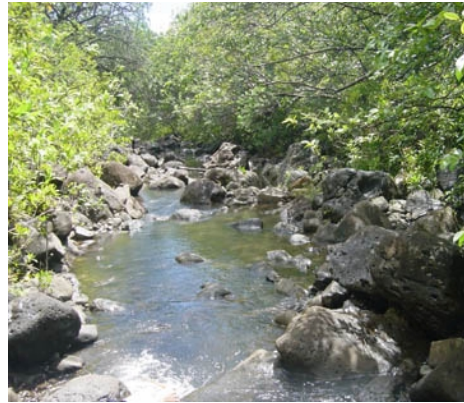
Figure 4. Upper Kipapa Site

The Upper Kipapa station is located N 21°28'13", W 157°57'40" upstream of USGS gaging station 16212800 near Wahiawa. The site has an elevation of about 700 feet. The Hawaii Stream Assessment code for Kipapa is 3-14-10.01. The USGS has peak and daily stream flow records from 1957 to present and water quality samples dating as early as 1968 and as recent as the year 2000. The land surrounding and above the site is primarily forested (Figure 4). DOH personnel conducted a visual assessment of the site in March of 2002 and a biological assessment of the site in June 2003.

Overall, the Upper Kipapa site scored “High” for habitat quality, using the Hawaii Stream Visual Assessment Protocol (HSVAP). All segments had low turbidity and, thus, scored in the very high range. Algal growth was relatively low at this site, scoring in the high to very high range. The channel condition and channel flow alteration scored in the very high range throughout the site. Embeddedness scores ranged from medium in the segments with slower moving water to very high in the segment dominated by cascades. Bank stability scores ranged from medium to very high; this divergence was likely due to the presence of human and feral pig trails close to the stream bank in one of the segments. Riparian condition scored in the high to very high category in all segments. Large ti plants, guava, mango trees and native ferns dominated the riparian vegetation. The canopy cover was open. Using this protocol, canopies with less than 20% cover obtain a score of zero (0). Therefore, two of the segments scored in the low range, and two scored in the very high range. This metric may need review since native canopies are thought to be relatively open. Many types of stream habitat were available in this segment, including pools, runs, riffles and cascades; therefore, available habitat scored in the high to very high range for all segments. No litter or trash was observed at the site; therefore, the Litter/Trash metric consistently scored very high.

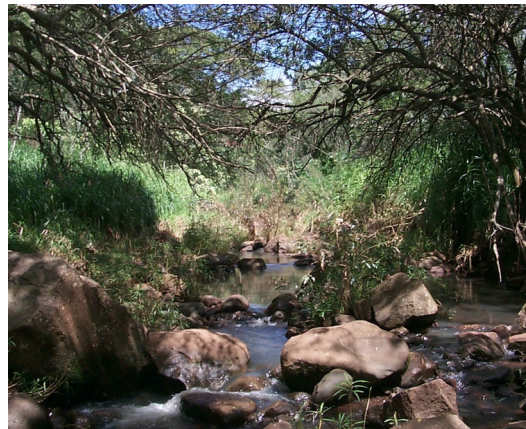
Figure 5. Lower Kipapa Site

The Lower Kipapa Site is located at N 21° 24' 27.0" and W 158° 00' 50.01" with an elevation of approximately 120 feet above sea level (see Figure 5). The watershed for the Lower Kipapa site is predominately agricultural and military land with some urban (residential) uses. Military contractors have conducted a few surveys of aquatic sampling sites upstream of this site when investigating the impact of leaks in an Air Force pipeline and associated storage tanks near the stream (EA Engineering, Science, and Technology. 1996; The Environmental Company 2001). DOH personnel conducted a visual assessment of the Lower Kipapa Site in April 2002 and a biological assessment of the site in September 2003.

Overall, the Lower Kipapa site scored “Medium” for habitat quality, using the Hawaii Stream Visual Assessment Protocol (HSVAP). Plant growth scored mainly in the high range throughout the site while channel condition scored mostly in the very high range. The site consistently scored in the very high range for channel flow alteration and channel condition. The site scored mainly in the low range for percent embeddedness. Bank stability ranged from medium to high to very high. The average site score for canopy was in the medium category. The canopy score for one of the segments scored zero due to heavy canopy, which brought down the average site score significantly. Riparian condition remained relatively constant scoring in the high category. Habitat available scores ranged from low in slower water segments to very high in the segments with swifter riffle/run habitat. Trash and turbidity scores were in the low category for the entire transect.

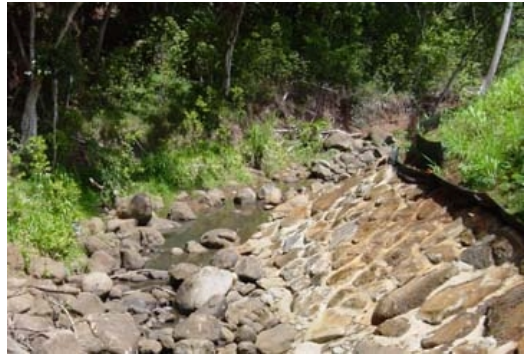
Figure 7. Upper Waikakalaua Site after Major In-Stream Construction

streambank upstream of the site was graded and left uncovered with bare soil exposed to the elements. Additionally, one of the banks within the site was lined with a stone and concrete revetment down to the streambed. The initial visual assessment was conducted prior to this in-stream construction in May of 2002 (Figure 6). The biological assessment was conducted in September of 2003. The DOH Clean Water Branch and our TMDL contractors (Oceanit, Inc.) collected multiple water quality samples below the site for TMDL development (Figure 7). Above the housing development the land area is forested. Construction employees, who worked near the sampling site, reported that the streambed was dry at this site during a brief period during the summer months of 2003.

The HSBP methodology was applied many months after the initial visual assessment to characterize the site. Unfortunately, major bank alterations extending into the channel width were made to the site. An additional HSVAP assessment was not conducted for this report. A significant decline in the score would be expected, considering DOH staff observed heavy siltation and other indicators of habitat degradation following construction. This site had “Nonsupporting” scores for habitat, using the HSPBP methodology. Habitat availability was suboptimal. Organic matter scores were marginal. Velocity-depth scores were suboptimal. Channel flow status was optimal. Channel alteration scores were in the optimal category. Bank stability, embeddedness and soil presence scores were poor. Riparian vegetation scores were marginal.

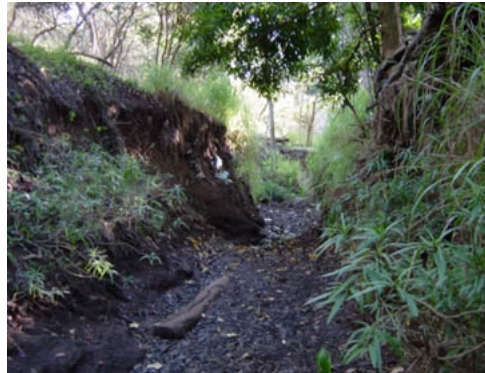
Figure 8. Lower Waikakalaua Site during Dry Conditions

The Lower Waikakalaua bioassessment site is located at N 21° 27' 49.6" and W 158° 01' 25.2" at approximately 540 feet above sea level. The site is located off Kamehameha Highway near a sewage pumping station and upstream of U.S. Geological Survey gaging station number 16212700. The USGS has peak stream flow records from 1958 to present and has conducted other studies at this site, including water-column, bed sediment and fish tissue studies. The DOH Clean Water Branch and our TMDL contractors (Oceanit, Inc.) collected multiple water quality samples below the site for TMDL development. Urban, agricultural and forested areas dominate the land use in the approximately 7 square miles of land that are drained by this part of the watershed (USGS 2003). Military land borders the western edge of the site while a sewage pumping station borders the eastern edge. A residential community lies upstream of the site. A visual assessment and a bioassessment were conducted in December 2002. On multiple occasions following this assessment, DOH staff documented that the stream channel at this site was dry (Figure 8).

The Lower Waikakalaua site was dry when DOH personnel conducted the HSVAP evaluation. Due to the lack of water, most of the elements of the protocol could not be scored and an overall score could not be generated. Nevertheless, preliminary investigations showed a lack of both bank stability and adequate riparian area. The vegetation that was present included a variety of introduced grasses, shrubs and trees, including strawberry guava, Christmas berry, California grass, eureka palm, false heather, java plum, alocasia, clidemia, ginger, wedelia and one banana plant. One kukui nut tree was also documented. Trash was evident throughout the site, including a large, rusted storage tank and a rubber chicken (Figure 14).

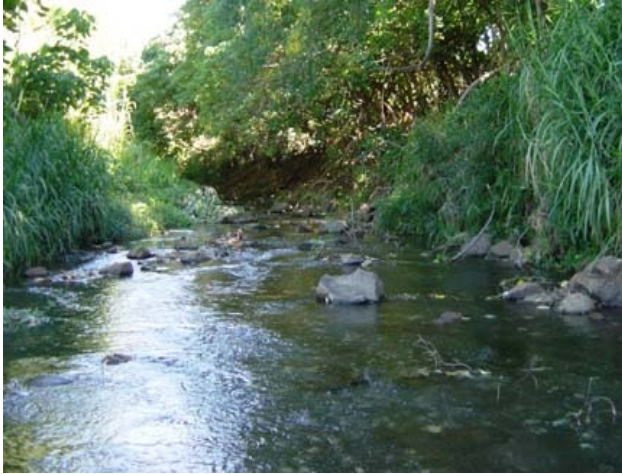
Figure 9. Lower Waikele Bioassessment Site

The Lower Waikele bioassessment site is located at N 21° 23' 11.3" and W 158° 00' 44.7" below the Waipahu Street bridge and above the U.S. Geological Survey's (USGS) gaging station (16213000). The site has an elevation of approximately 40 feet above sea level. The USGS has peak and daily stream flow records at the gaging station for most dates from 1951 to present and water quality data sporadically from 1967 to 2002. Real-time stream flow data is also available on the USGS website. The USGS also has

to the Waipahu Street bridge. DOH personnel completed a visual assessment of the site in June 2003, and a bioassessment of the site in September 2003 (Figure 9).

The Lower Waikele site scored in the “Medium” range for habitat quality, using the Hawaii Stream Visual Assessment Protocol (HSVAP). Turbidity was relatively low perhaps due to the input from multiple groundwater seeps into the stream. Conversely, the slower, deeper sections of the stream accumulated fine sediments both in the water column and on the bottom of the stream. Algal growth scored low throughout the segment due to a persistent algal scum on the rock substrate. The channel condition was naturalized after an obvious anthropogenic stream alignment. Channel flow did not seem to be highly impacted by artificial water withdrawals or discharges though one small intake pipe was identified, during the survey. Embeddedness scores ranged from medium in the segments with slower moving water to very high in the segments dominated by shallow riffles. The left bank was steep with little riparian area and had a two lane road within a few meters of the stream while the other side of the bank was dominated by alien grasses. Bank stability and riparian condition scores were low throughout the segment. The canopy cover scores were variable throughout the segment since the canopy ranged from closed to open. Although riffles and runs primarily dominated the site, habitat from cold-water groundwater seeps was also

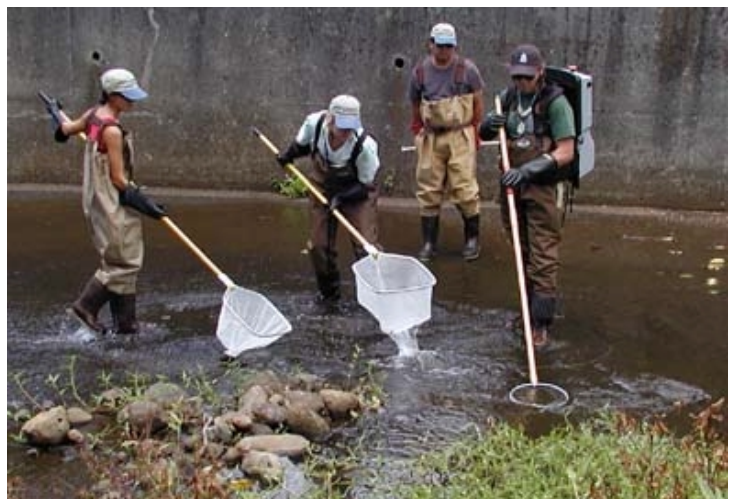
Figure 10. Electrofishing Training in Manoa Stream

Each biological assessment followed the Hawaii Stream Bioassessment Protocol (HSBP). Electrofishing techniques (Figure 10) were utilized in place of underwater visual census only when waters were (1) thought to be polluted to a point that posed a risk to human health, (2) too turbid to examine fish adequately underwater, (3) dominated by small introduced fish that were difficult to count underwater or (4) not deep enough to snorkel. Only trained and closely supervised personnel with proper safety equipment were allowed to conduct the electrofishing for this sampling effort.

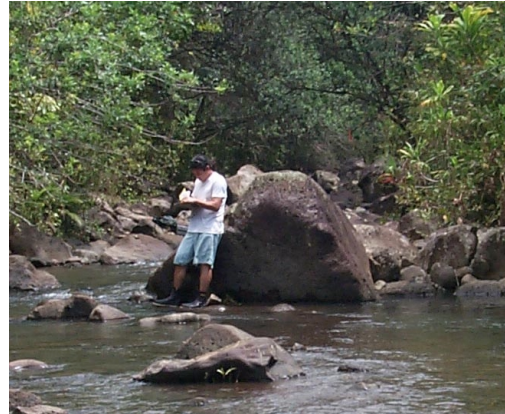
Figure 11. Scoring the HSVAP Protocol at the Upper Kipapa Site

HSVAP Score:

Score 1.7 out of 2.0

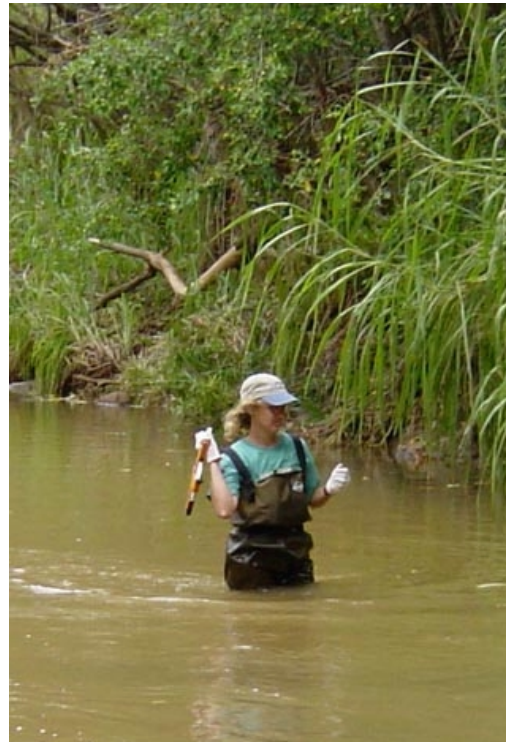
Figure 12. Linda Koch wading through the Lower Kipapa Site after conducting the HSBP

HSVAP Score:

Score 1.3 out of 2.0
 Average Habitat Rating Medium

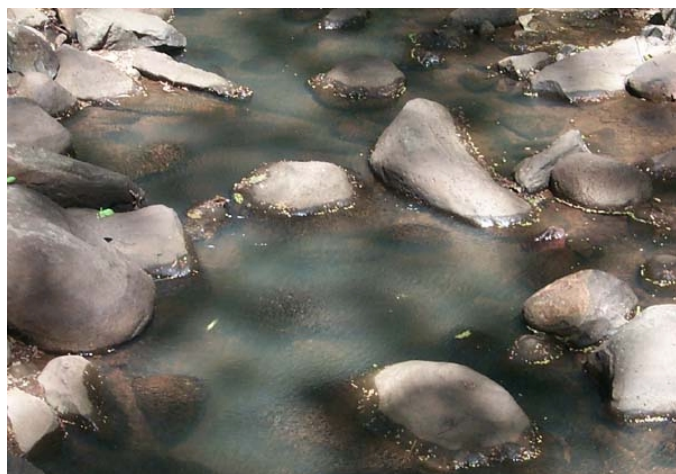
Overall, the Upper Waikakalaua site scored “High” for habitat quality, using the Hawaii Stream Visual Assessment Protocol (HSVAP). The water at the site had a distinctive milky white tint; in spite of this, the site scored very high for turbidity because objects were visible at depth. Plant growth and channel flow alteration scores were also in the “very high” category. Channel condition scores, riparian condition and bank stability scores were slightly lower because of alteration to the bank and channel from preliminary construction for a housing development. Embeddedness scores ranged from low in slower riffles and runs to high in the faster habitats. Canopy, Habitat Available and Litter/Trash scores were high throughout the site.

Figure 13. Milky Color at Upper Waikakalaua Site

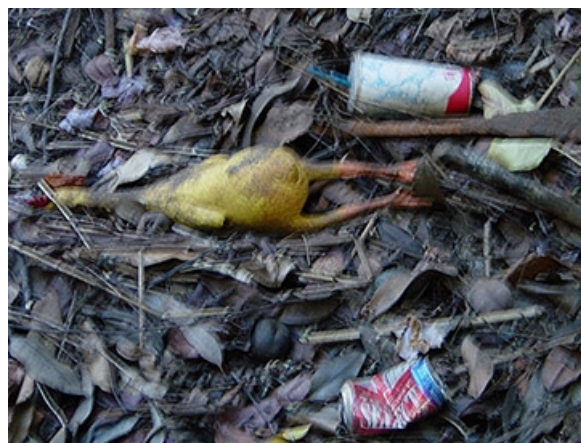
Figure 14. Trash at Lower Waikakalaua Site

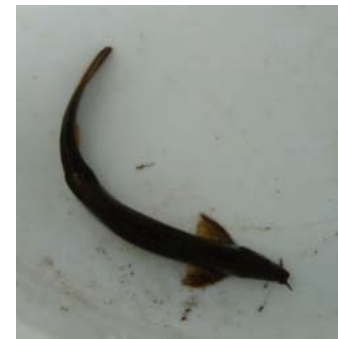
The HSBP methodology showed the Lower Waikakalaua site to be impaired. Sampling at this site recovered only alien aquatic fauna. Topminnows, such as the common mosquito fish (*Gambusia affinis*), guppies (*Poecilia reticulata*) and mollies (*Poecilia* spp.) and green swordtails (*Xiphophorus helleri*) were sampled. Crayfish (*Procambarus clarkii*) and a dojo (*Misgurnus anguillicaudatus*) were also collected. The introduced grass shrimp, *Neocaridina denticulata sinensis*, were also abundant.

Figure 15. Dojo (Misgurnus anguillicaudatus) found at Lower Waikakalaua Site

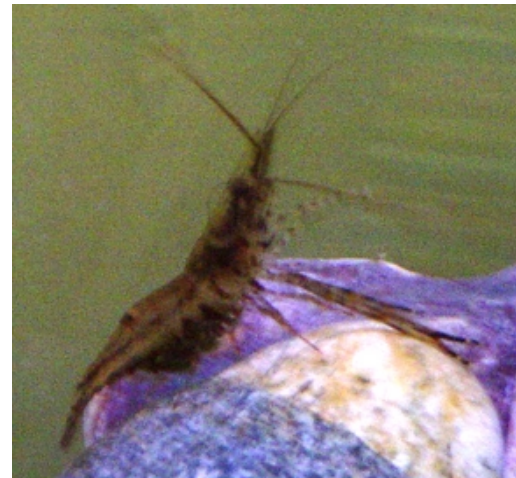
The HSBP methodology showed the Lower Waikele site to be moderately impaired. This site was dominated by alien species. Only one native ‘o’opu nakea (*Awaous guamensis*) and many native prawns (*Macrobrachium grandimanus*) were sampled. Many of the female native prawns were carrying eggs or “berried” (see Figure 15). Tahitian prawns (*Macrobrachium lar*) were also found at the site. Topminnows, such as the common mosquito fish, *Gambusia affinis*, guppies (*Poecilia reticulata*) and mollies (*Poecilia* spp.) have invaded the site. Bristlenose catfish (*Ancistrus* sp.), green swordtails (*Xiphophorus helleri*) and crayfish (*Procambarus clarkii*) were also collected. Introduced grass shrimp, *Neocaridina denticulata sinensis*, were also abundant. Although small mouth bass (*Micropterus dolomieu*) were sighted during previous investigations of the site and bass fishermen were also encountered, none were collected during this assessment.

Figure 16. Berried Female 'opae 'oeha'a from Waikele Stream
